**“COMPRESSOR HASN’T RUN THIS QUIETLY OR SMOOTHLY  
IN 18 YEARS OF OPERATION”  
A CASE STUDY ABOUT FIELD DE-TUNING OF MECHANICAL  
RESONANCE ON FIXED SPEED SCREW COMPRESSOR PACKAGES**

**ABSTRACT**

A field vibration analysis was conducted on a refrigeration screw compressor unit. The purpose of the analysis was to field de-tune high vibration on the compressor package.

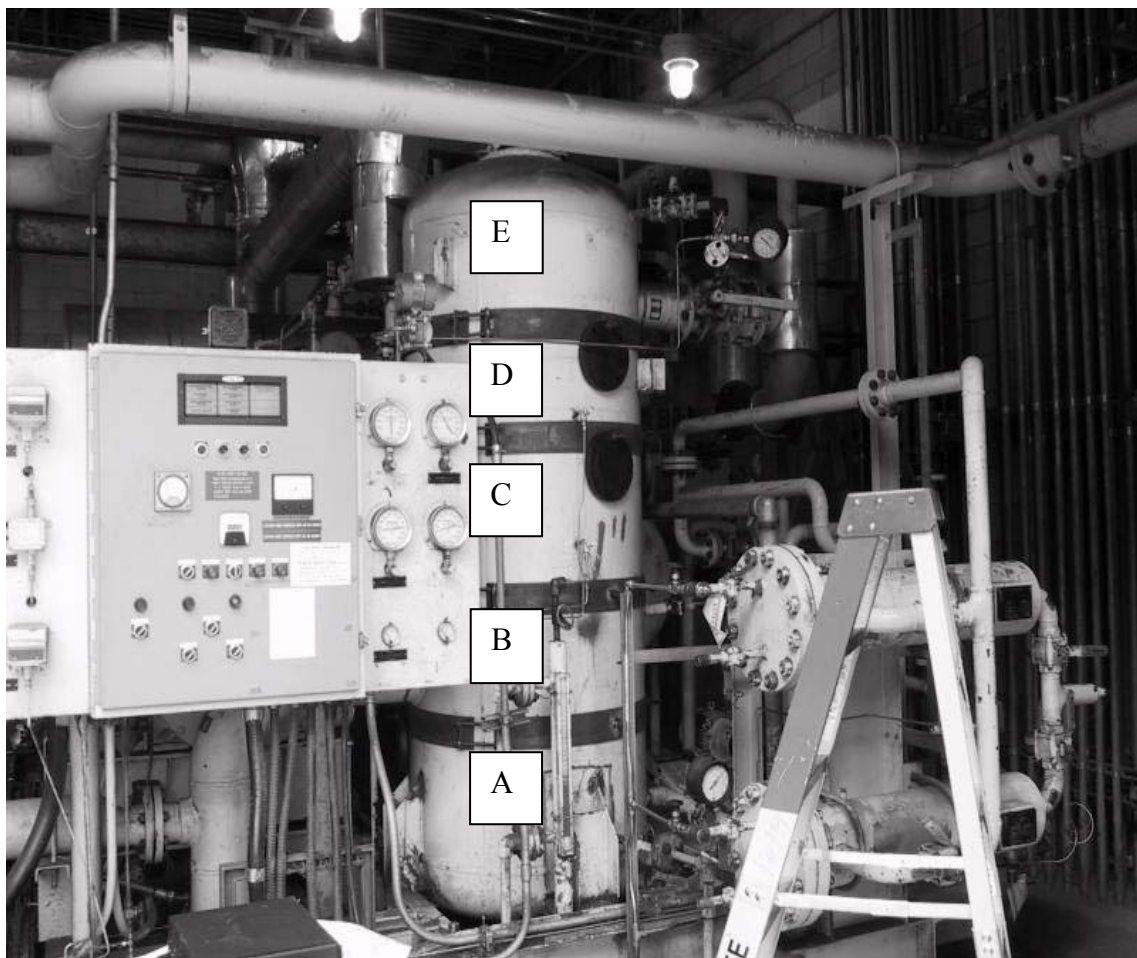
2.1 One of the areas that high vibration had been a major concern was the compressor discharge separator (vessel D118). The predominant frequency of the high vibration on this unit was 119 Hz (lobe passing frequency on the screw compressor). At these frequencies the vessel shell modes were a main concern. The thought process prior to beginning the field detuning was to affect the vibration modes by adding mass to the shell of the vessel. For attaching trial

weights, four band clamps were constructed that would fit around the outside of the D118 discharge separator. The clamps were made of ¼" thick plate 4" wide with four studs welded to them to facilitate hanging 4" 150# blind flanges from the band clamps. The band clamp material size was chosen for ease of construction and handling. The 4" 150# flanges were specified because they offered a reasonable weight increment (15 lbs), were easy to handle, and were a common stock item at the plant. Vibration levels were measured on the vessel at five locations along the height of the weld seam. At the start of the testing the peak vibration measured on the vessel was at location B shown in Figure 1. The maximum as-found amplitude at location B was 1.65 inches per second peak at a frequency of 119 Hz.

Figure 1: Discharge separator vessel D118 test point locations.

Example plots of vibration data recorded on June 13, 2002 are presented later in this paper. All four band clamps were installed with eight 4" 150# blind flanges secured to the bands at various locations around the vessel. At the conclusion of the project the maximum vibration recorded on the vessel was at location B with a peak of 0.19 inches per second.

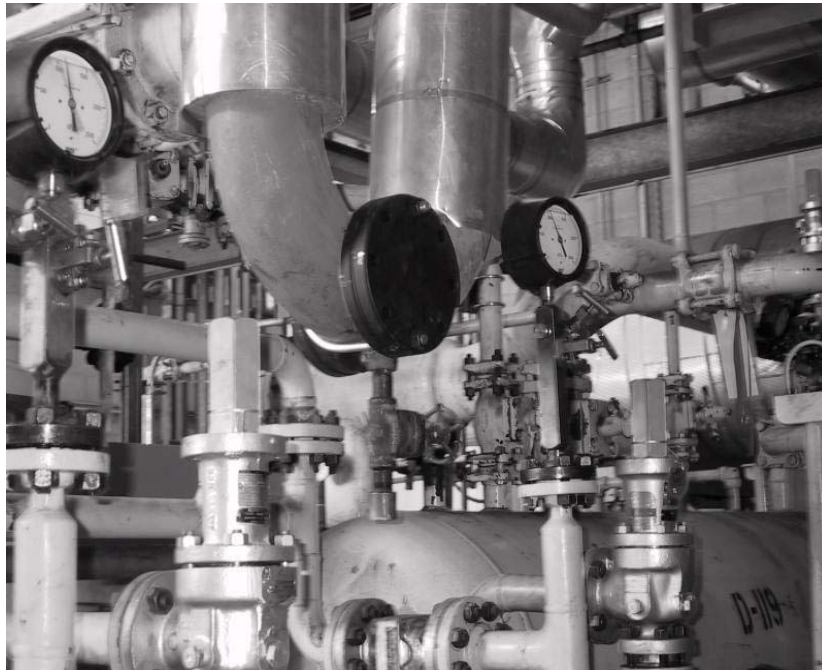
2.2 Very high vibration was observed on the separator discharge piping. Vibration levels greater than 4.0 inches per second peak were observed at a frequency of 119 Hz on the lower elbows of the discharge line. The vibration on the discharge line drain valve was extreme, measuring greater than 9.0 inches per second peak. 4" 150# blind flanges were u-bolted one at a time to the discharge piping as shown in Figure 2. Vibration levels were checked after each flange was secured in place. With four blind flanges secured, the vibration on the discharge line dropped to a peak of 0.8 inches per second. Vibration on the drain line was still marginally high at a peak of 2.0 inches per second. At this point there was a noticeable decrease in the noise level around the C118 compressor.

Figure 2: Discharge piping from vessel D118 with de-tuning weights secured.

Adding this de-tuning weight resulted in a considerable reduction in the vibration levels. At the conclusion of the project with all the de-tuning weights installed, an even more dramatic reduction in levels was observed. Final readings on the discharge line were measured to be 0.42 inches per second peak at 119 Hz and the level on the drain line dropped to 0.115 inches per second peak at this same frequency.

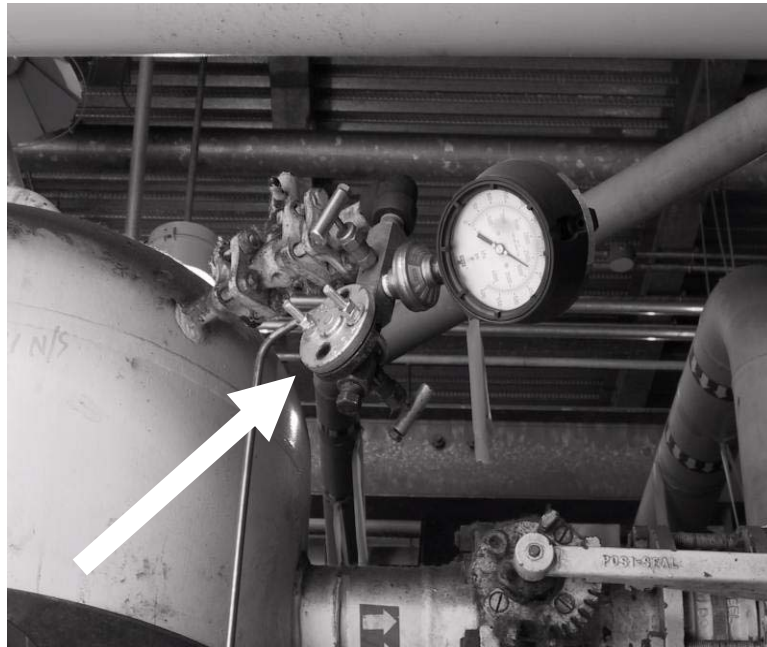
2.3 High vibration was observed on the vessel pressure gauge and tubing line located at the top of D118. The 119 Hz buzz was considerable on the stainless valve and tubing line. The gauge needle was vibrating to the point where it could not be read. Adding two 1/2" blind flanges as shown in Figure 3, eliminated the high vibration on the tubing line and pressure gauge.

Figure 3: Vessel D118 pressure gauge and tubing line de-tuning weights.

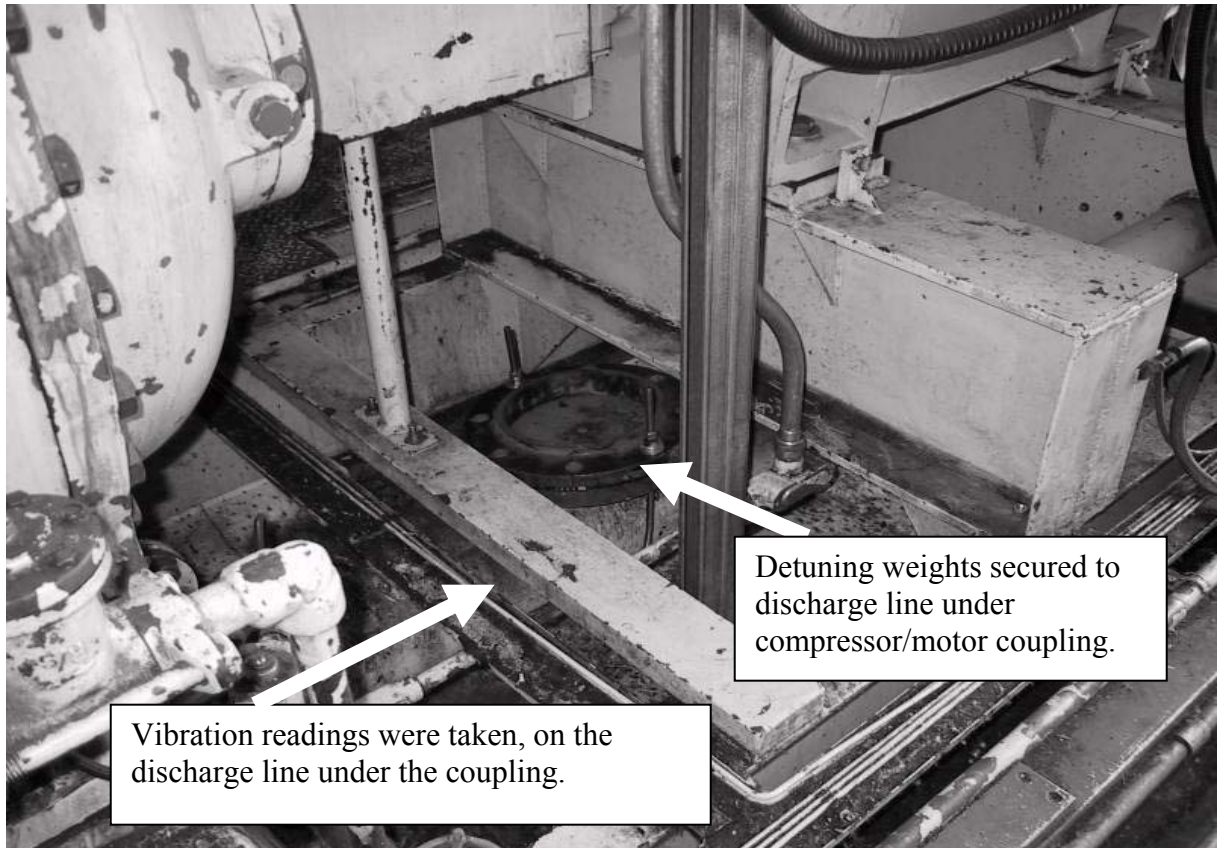
2.4 The discharge line between the compressor and the separator D118 exhibited high vibration. Initially vibration levels on the pipe in the vertical direction measured 3.4 inches per second peak at a frequency of 119 Hz. Several tests were conducted to determine the effect of the pipe clamp located under the coupling end of the motor. The greatest reduction in vibration levels on the discharge piping was achieved with the pipe clamp removed and two sets of de-tuning weights clamped to the discharge line. A set of weights was located on the discharge line directly under the compressor / motor coupling and another was installed at the lower elbow of the discharge line into the D118 vessel. Both sets of weights were secured with a bent length of ready rod and were made up of 8" 150# blind flanges and rings. Final vibration levels on the discharge line under the coupling were measured to be 0.21 inches per second peak in the horizontal direction and 0.85 inches per second peak in the vertical direction, both peaks were at 119 Hz. Vibration levels on the discharge pipe, just before the elbow rising up to the vessel, saw reductions at 119 Hz from 1.3 inches per second peak to 0.15 inches per second peak in the horizontal direction. At the same location and frequency, vertical vibration dropped from 2.8 inches per second peak to 0.58 inches per second peak. The de-tuning weights installed on the discharge line are shown in Figures 4 and 5.

Figure 4: Discharge line de-tuning weight located under compressor/motor coupling.

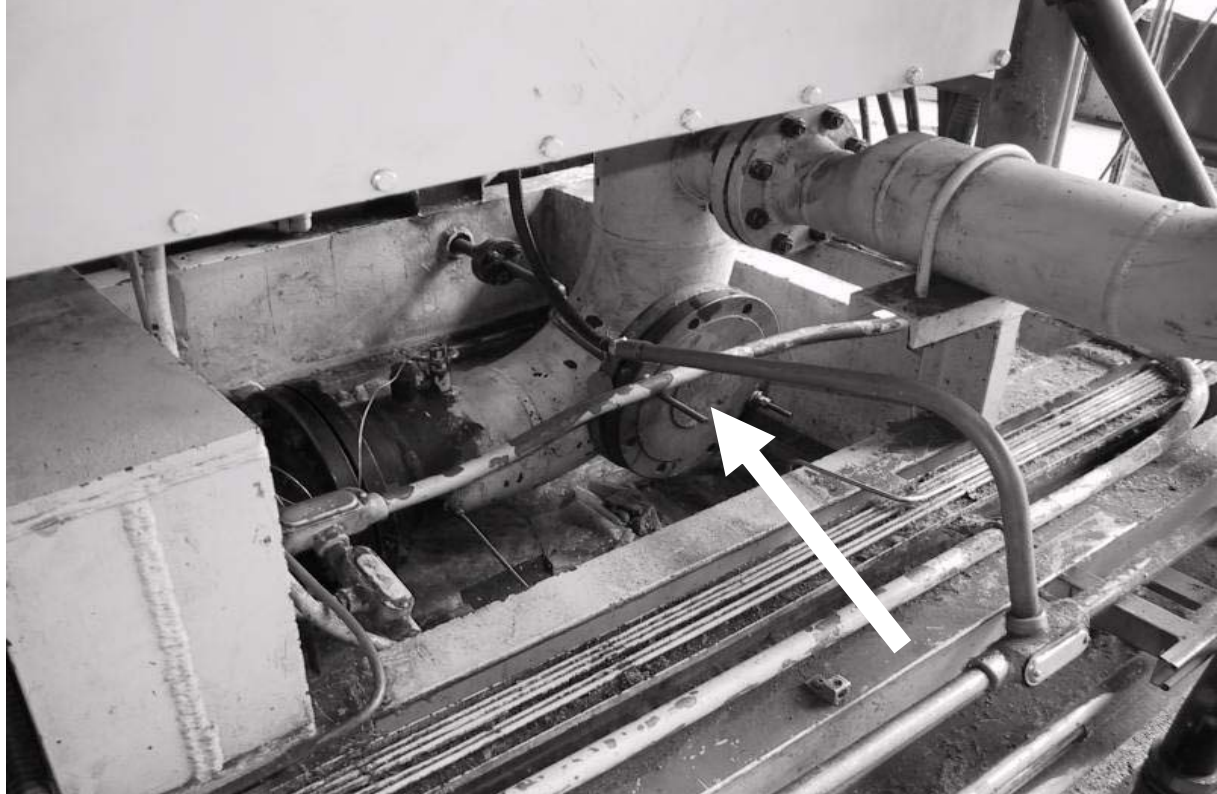
Figure 5: Discharge line de-tuning weight located at lower elbow before D118.
