RESTORING CRANKSHAFT ALIGNMENT: A CASE HISTORY

Mark L. Deutscher, P.Eng.
Canadian Design Services Representative

Beta Machinery Analysis Ltd., Calgary, AB, Canada, T3C 0J7

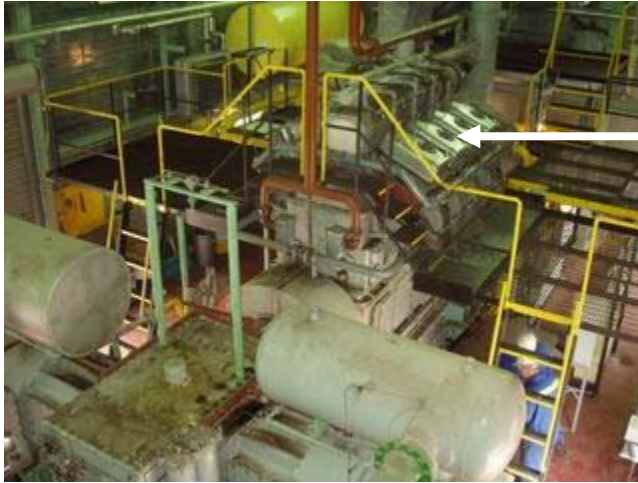
Figure 1: Picture of Engine-Compressor, compressor in foreground. Note the beautifully polished valve covers on the engine.

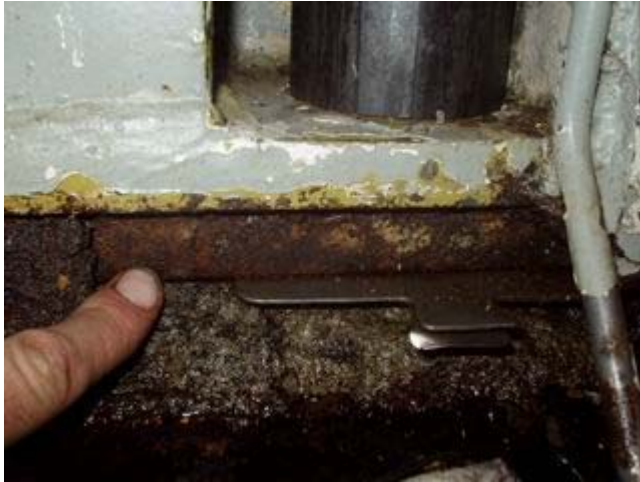
Figures 5 and 6 are photographs of the actual grout connection with the exterior grout chipped away.

Figure 5: Photo of actual grout connection. Finger points to shimming location between rail and top of grout.

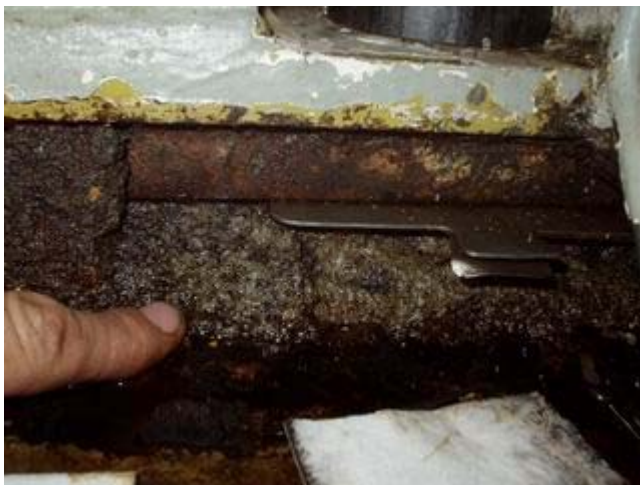
Figure 6: Photo of actual grout connection. Finger points to location where most relative motion can be felt or seen.

- Foundation slab itself is in good shape.
- Grout to foundation slab connection appears to be in poor shape with relative motion visible at several locations. This is most noticeable on engine left hand side and compressor right hand side. Oil can be seen squirting out of cracks in the grout. NOTE: De Laval installation specification calls for sand with Portland cement or approved epoxy grout. The grout used was relatively coarse sand and Portland cement.
- Engine vibration is reasonable. Dominant component is at 2x run speed, with the engine moving 2.3 mils p-p horizontally at a point near the front, with much less vibration at the rear of the engine. Areas of higher vertical vibration amplitude at the equipment base correspond to areas of higher horizontal vibration of the engine.

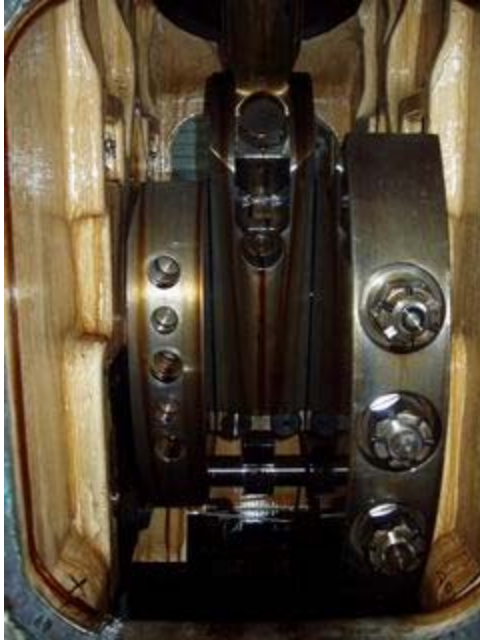
- The cold, as found web deflection was -4 thou at engine throw #4. Throw 4 is closest to flywheel and indicates that the throw was tight at the bottom. See Figure 7 for a photo. This was consistent with our developing hypothesis that motion at the front of the engine and rear of the compressor had, when ever the anchor bolts were loose at least, worn away at the grout and sagged downwards.

Figure 7: View of engine crankshaft throw #4 with web deflection gauge installed

- The web deflection at throw four, nearest the coupling, was reduced from -4 mils to -1.75 mils by leaving the first four anchors on each side of the front of the engine tight, loosening all the other anchors and jacking up the compressor sub base. Progressively thicker shims were installed to the rear of the compressor base. The rear of the compressor base was raised approximately 100 mils. The shims were installed in the gap which opened up between the bottom of the rail and the top of the grout surface. Table 1 below shows the "as left" web deflection after shimming.

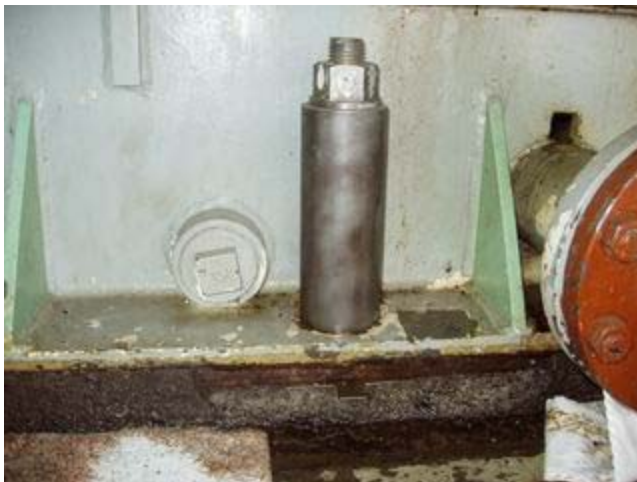
Figure 8: Typical anchor bolt extension, 8” tall unless clearance limited height.

- Unit will continue to run.
- Owner makes commitment to have anchor extensions installed on at least all the accessible anchor locations and has them installed eventually with good results.

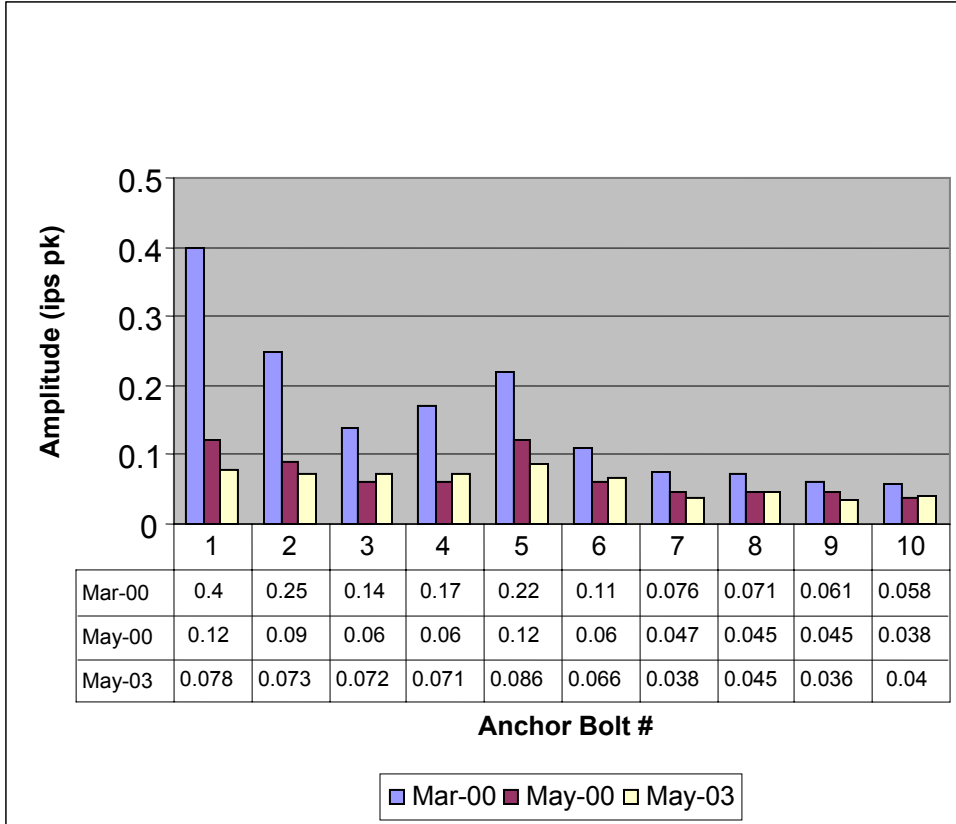
- Anchor bolts are all tight with results very similar to last inspections. For the most part barely noticeable relative motion at grout to concrete interface at all except at anchor location #5 and at the end of the compressor.
- Engine vibration remains at good levels, the following plots on Figures 9 through 12 compare vibration from the last three visits.

Figure 9: Summary of 2X vertical vibration, left anchor bolts

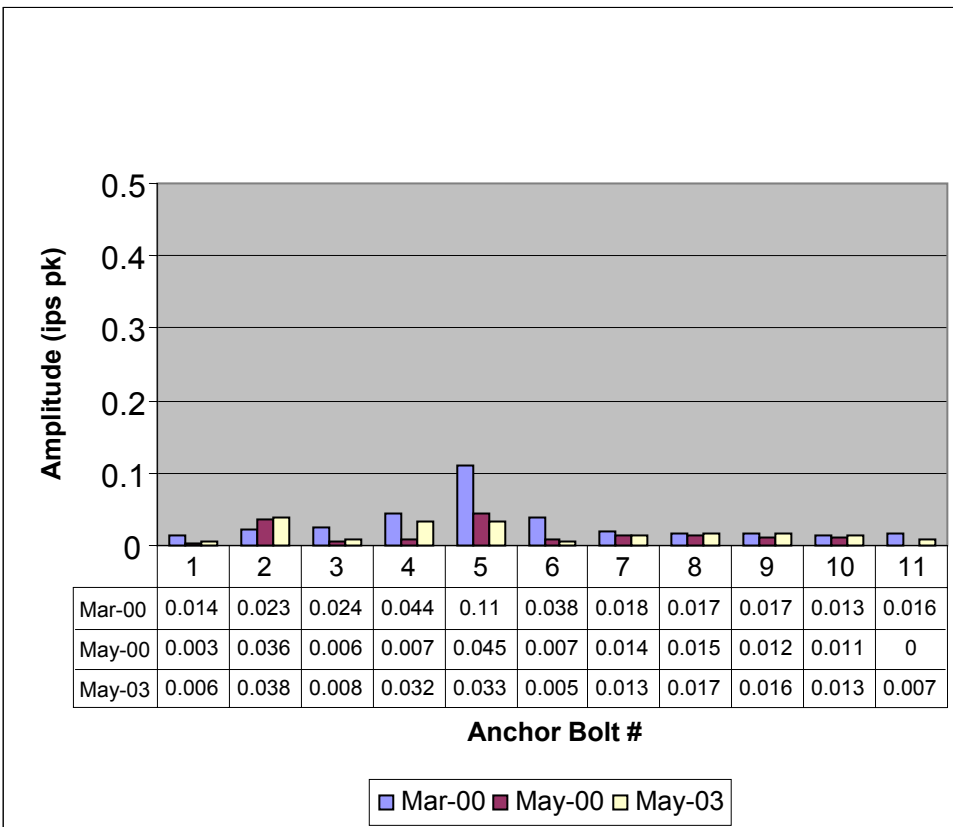
Figure 10: Summary of 2X vertical vibration, right anchor bolts

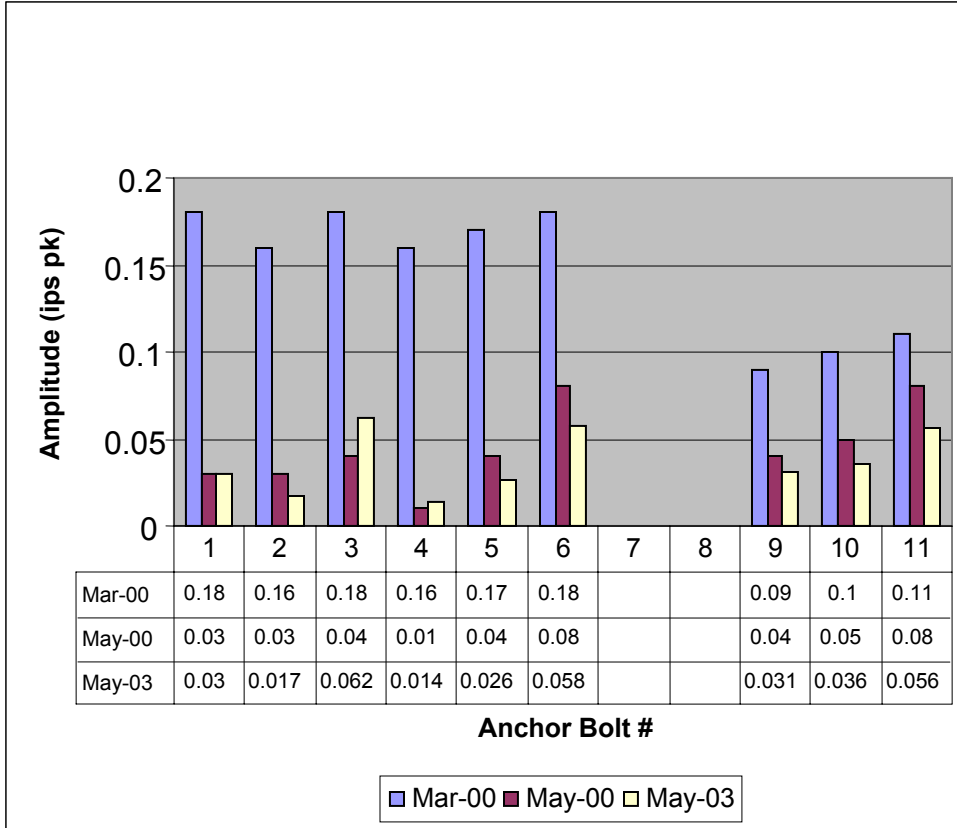
Figure 11: Summary of 2X horizontal engine and compressor vibration

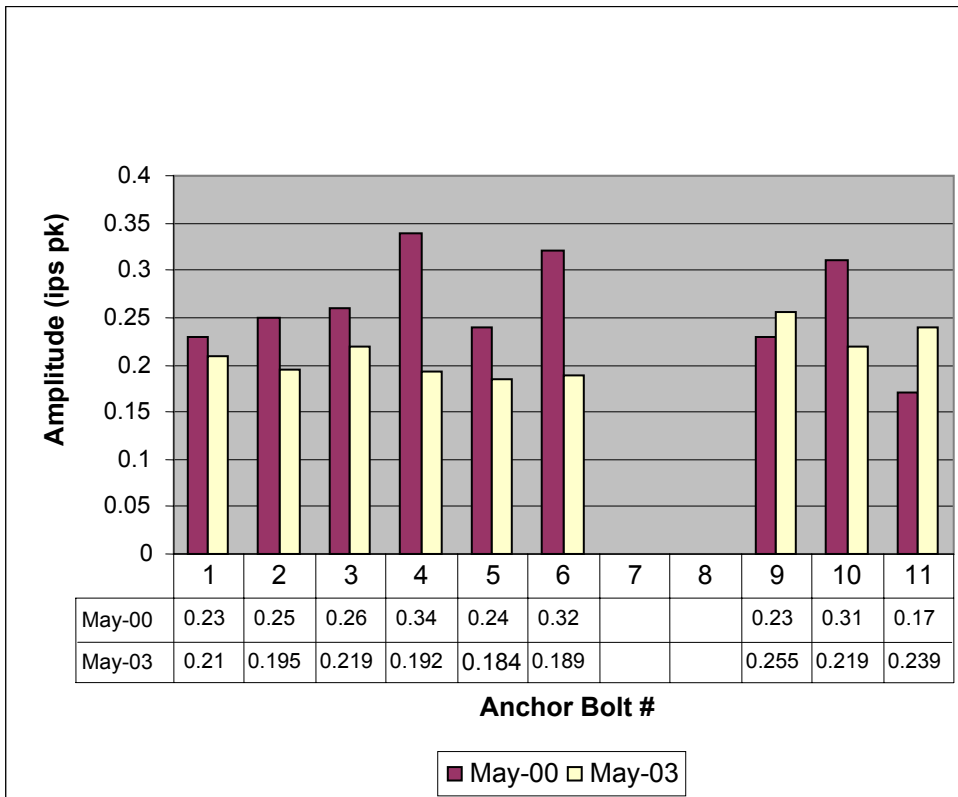
Figure 12: Summary of Overall horizontal engine and compressor vibration
