## A CASE STUDY OF A FLOW-INDUCED TORSIONAL RESONANCE

*William F. Eckert, P.Eng., Ph.D.*  
*Field Services Manager*

Beta Machinery Analysis Ltd., Calgary, AB, Canada, T3C 0J7

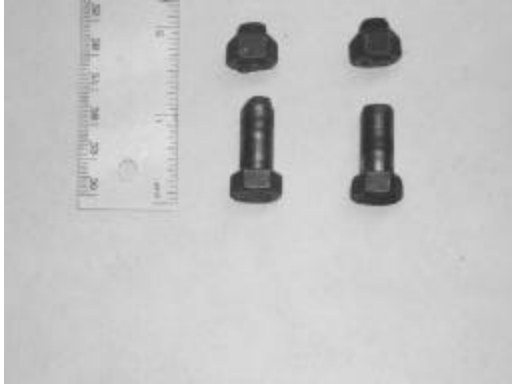
An evaporator compressor at a processing facility had run successfully for years with a 450 HP variable frequency drive (VFD) electric motor. For production reasons, the unit was modified to a 600 HP VFD. With the larger motor, the coupling unit failed several times (broken bolts with less than two weeks of run time for each failure). The coupling is a Thomas Series 52 flexible disk with spacer. See Figures 1 and 2.

**Figure 1.** Broken coupling bolts

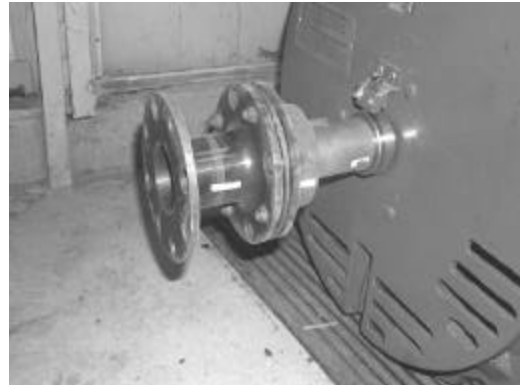
**Figure 2.** Coupling on 600 HP motor
