A GEARBOX VIBRATION - FACT OR FICTION

Brian C. Howes

Beta Machinery Analysis Ltd. Calgary AB, Canada, T3C 0J7

A case study of a gearbox. Late last fall, routine monitoring of a gearbox showed an increase in overall vibration levels, which was not apparent in the spectra. If the gearbox failed during the winter, the process plant would not have been able to start up again until spring. Plant engineers called us in to determine whether the gearbox would run through the winter. The investigation uncovered problems with the way the routine monitoring was done. As well, vibration was present in the spectra that seemed to be unrelated to gearmesh frequency. Was there a problem or not?

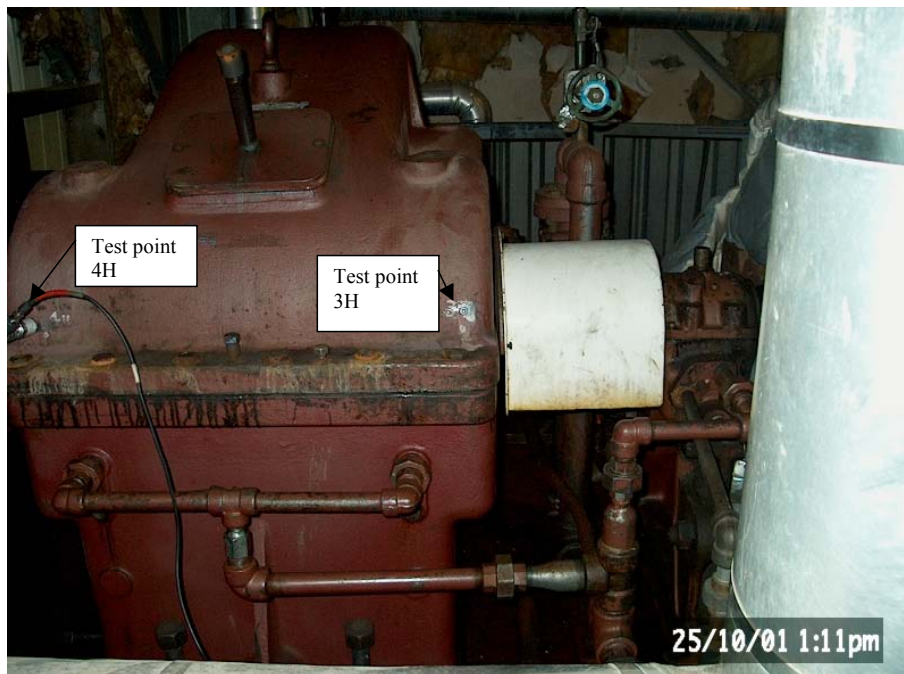
Picture 1: High speed side of the box, Test Points 3 and 4: (Turbine to the right)

Vibrations were collected in a similar manner at Test Points 3, 4 and 5 in the horizontal direction. Refer to Pictures 1 and 2 for details of the test point locations.

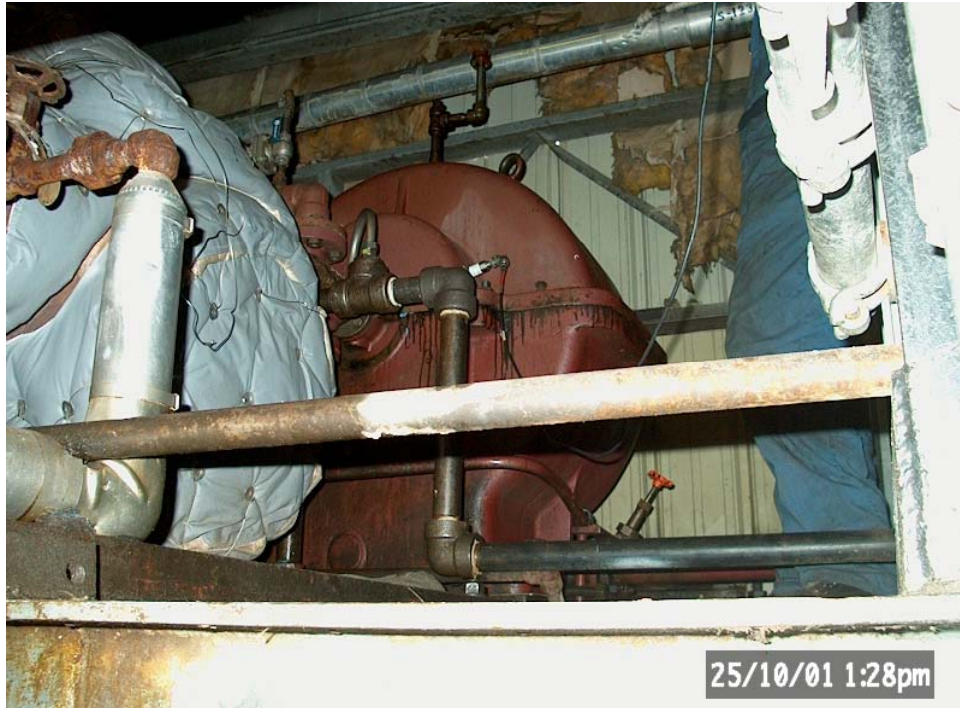
Picture 2: View of Test Point 5 with accelerometer mounted with stud on nut glued to box in Horizontal orientation. The oil pump is on the turbine side of the low speed shaft.

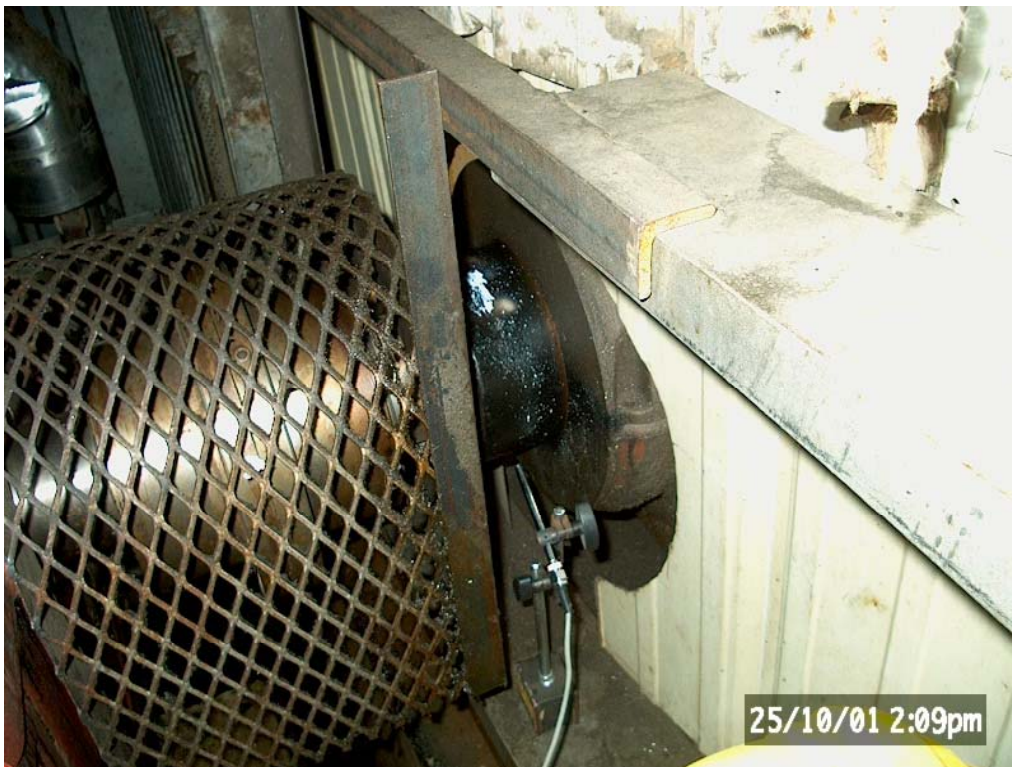
Picture 3: Optical pickup on the low speed shaft. Once per turn mark was put on the shaft while it was running.

Refer to Picture 3 for details of the once-per-turn setup. As noted, the mark was put on the shaft without shutting down the unit.

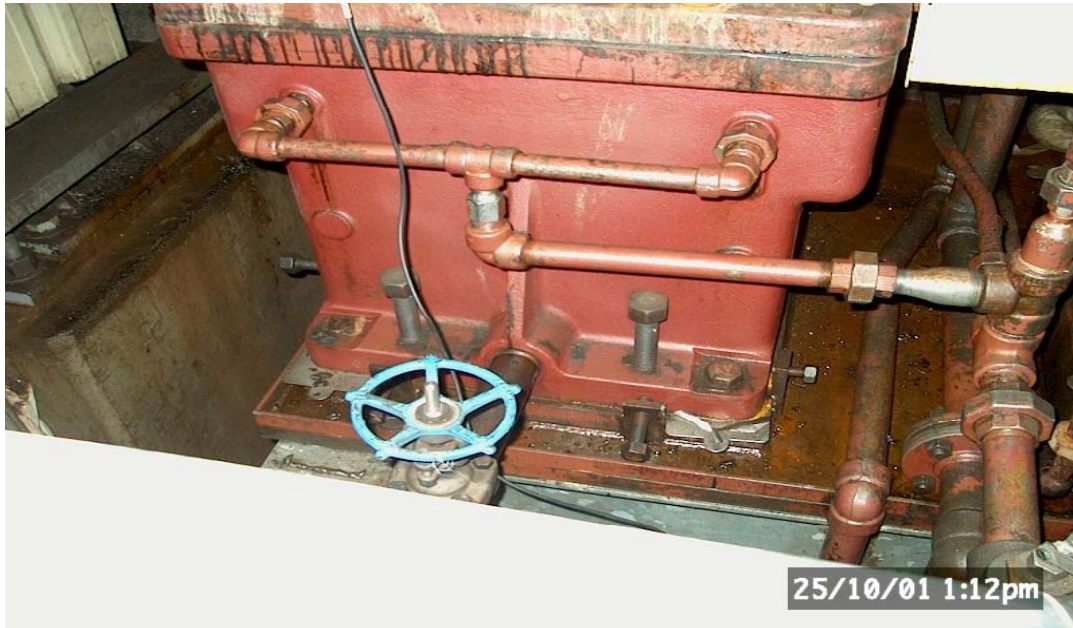
Picture 4: Gearbox base on the south side.

Picture 4 shows the feet of the gearbox on the south side. This is shown in connection with the soft foot check that was done. We checked for the effect of a soft foot on the vibrations by loosening and tightening one foot at a time. The change in vibrations was noted for each of the four feet. Foot 5 showed the largest change in vibrations. The overall vibrations (from the time domain data) decreased by 6%. The amplitude of the vibration at 4828 Hz decreased by 22% when the anchor bolt was loosened.

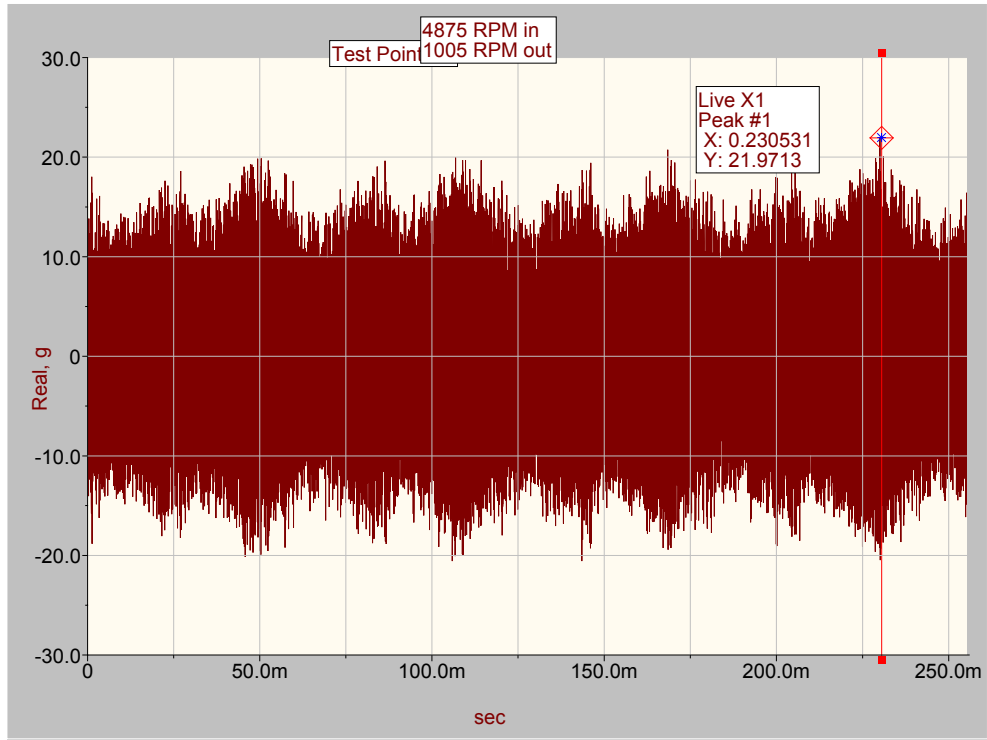
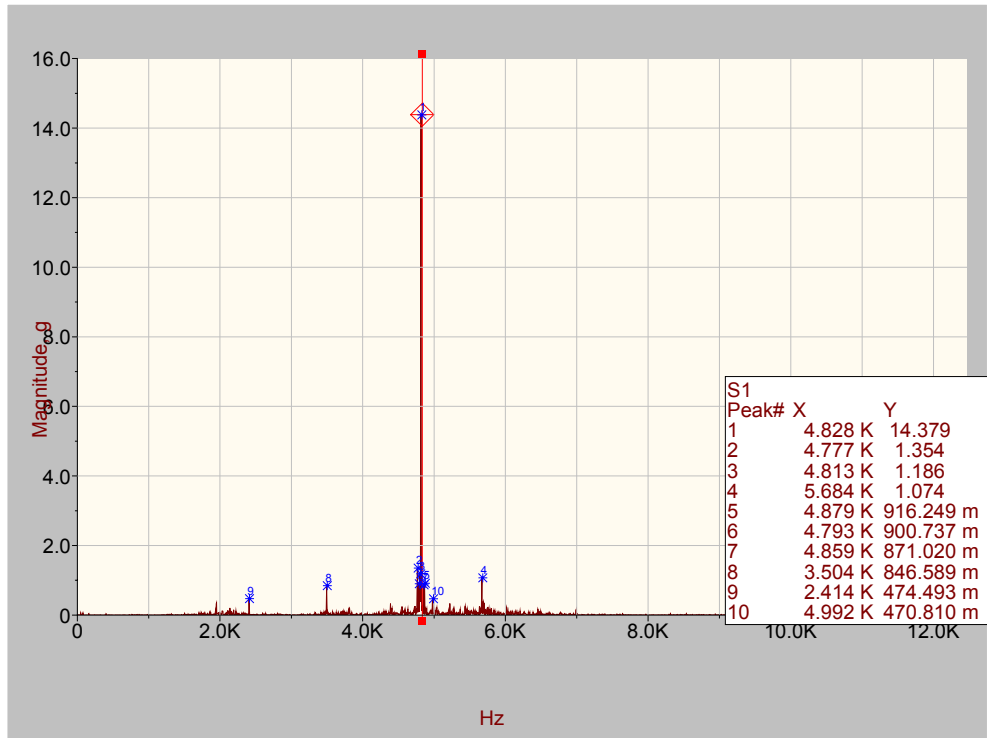
Figure 1: Test point 6H Acceleration Data

Figure 1 is representative of the data. It was collected in the horizontal direction, near the bearing on the output side of the low speed shaft. The accelerometer was mounted on a nut, which had been glued to the gearbox.

Based on the speed of the output shaft and the number of gear teeth given to us, the gearmesh frequency was 3494 Hz. Note in the spectrum plot in Figure 1, that there is a peak in the acceleration spectrum approximately at this frequency (3504 Hz). However, the major peak in the spectrum is at 4828 Hz, which is 1.38 times gearmesh frequency.

Close inspection did not disclose significant amplitudes at harmonics of gearmesh, or sidebands. The time domain data did not show any spikes. Generally, the gearbox looked to be in good condition based on normal dynamic indicators, except for the unusual peak at 4828 Hz.

Further analysis of the 4828 Hz peak could not be done because of restrictions on changing speed. However, it can be seen that there are many small peaks around the main 4828 Hz peak. This energy is consistent with the idea that there is a mechanical natural frequency (MNF) of the gearbox case that is at or near 4800 Hz. Changing the speed of the unit would have permitted us to test this theory. Experience has shown, however, that frequently there are MNFs which are excited in a gearbox. While it is not a particularly good sign, it is not

necessarily an indication of a serious problem with the gearbox in the absence of harmonics and sidebands. It is more likely a sign that the gearbox manufacturing tolerances were looser than what can be achieved (but at what cost?).

We concluded that the gearbox was in good enough condition to run till the planned turnaround next spring. We did, however, recommend doing a few additional checks to ensure that this conclusion was correct. We recommended checking the oil in the gearbox for wear metals. We also recommended checking the oil filters for any sign of metal.

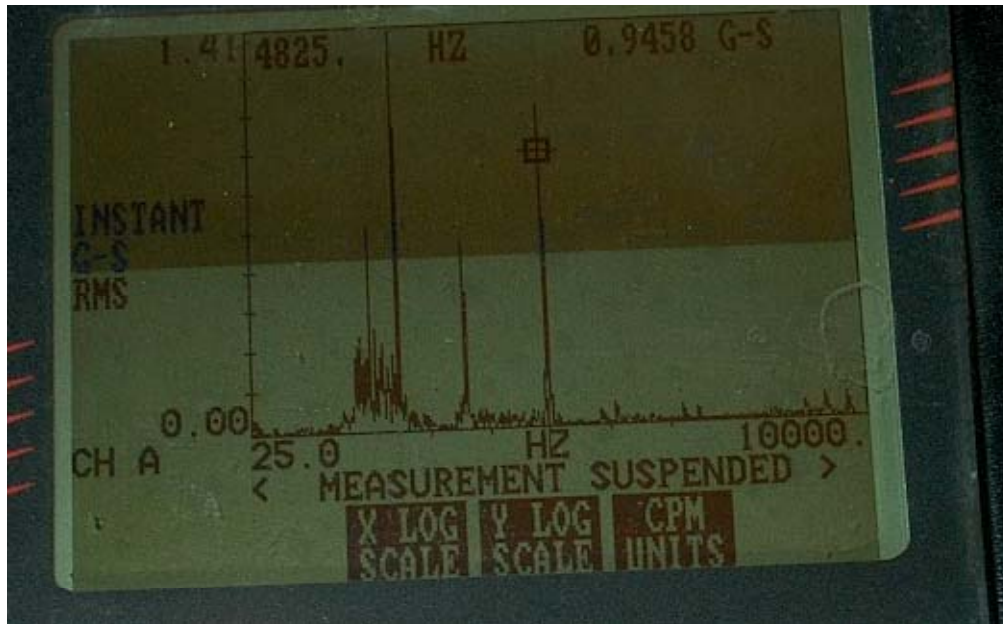
Based on experience, we were suspicious of the use of either handheld or magnetically mounted accelerometers for collection of data above 1000 Hz. To test the effect of a magnetic mount versus a stud mount, we did a test. The results of the test are shown in two photographs of the screen of the instrument (Pictures 5 and 6).

Observe the dramatic change in vibration energy below the gearmesh frequency peak at 3500 Hz. Stud mounting increased the amplitudes of the peaks at gearmesh and 4820 Hz. The good news is that all of the peaks are present, albeit at different amplitudes, in both spectra.

The biggest reason for not using a magnet to mount an accelerometer for high frequency measurements is the desire to collect data repeatably. The frequency response of the accelerometer is influenced by the connection of the magnet to the gearbox. Changes in the thickness of the paint will change the frequency response and produce an apparent change in the condition of a gearbox. Dirt under the magnet will do the same thing. Poorly mounting the magnet (not “wiggling” the magnet to ensure the magnet is solidly mounted) will do the same.

But one of the most significant sources of lack of repeatability is a loss of magnetic strength in the magnet. This comes with time and use (or misuse) of the magnet. Instructions with magnets tell the user to slide the keeper (usually a steel washer) on and off the magnet. It is a natural tendency to let the keeper impact the magnet. This is bad. It tends to realign the magnetic particles in a random order, thus causing a loss of magnetic pull. In this case, the magnet that came with the collector was not particularly strong and it seemed to be even weaker than experience suggested it should have been. Changes in the magnet may have been the reason for the increase in overall vibrations.

Picture 5: Vibrations at 6H with magnet mount

Methods of mounting of transducers, such as accelerometers used for measuring high frequency data, are important. Repeatability of data collection is the most important consideration in choosing a mounting method.

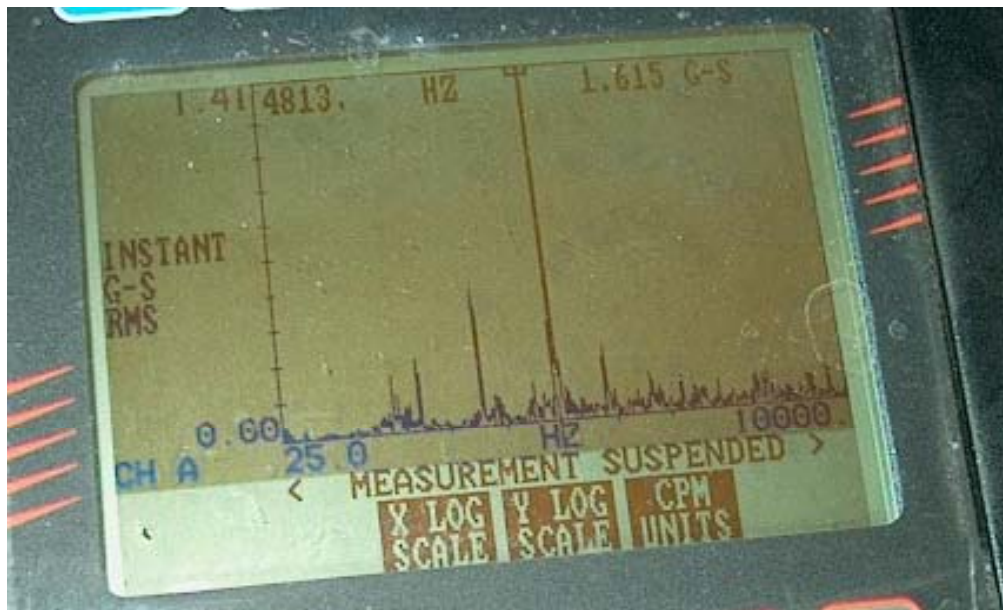
Picture 6: Vibrations at 6H stud mounted
