## **PAPER MACHINE SPEED INCREASE TRIAL**

### **ABSTRACT**

A large-scale speed trial of a paper machine was successfully completed using temporarily mounted transducers and data acquisition systems. Logistical and environmental issues were overcome to produce an understanding of the machine's vibration behavior at future speeds, and to shed light on ongoing vibration issues.

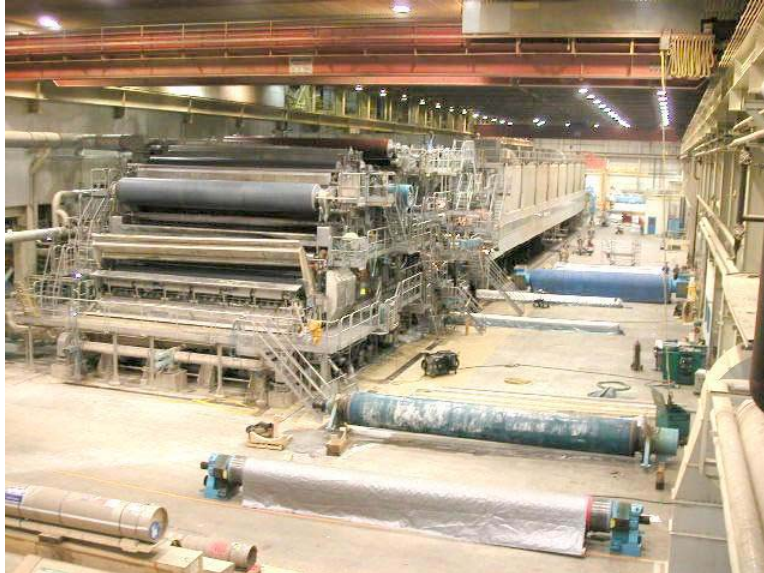
Figure 1. The paper machine viewed from the former section towards the dryer end, showing the front or tending side of the machine. To the right of the paper machine can be seen the roll and felt laydown areas needed for the shutdown. Monitoring equipment was located just beyond the blue roll at the wet end of the dryer, and at the far end of the dryer.

The job had many challenges on the instrumentation side of it. All of the vibration and tachometer channels monitored during the speed trial were temporarily mounted on the machine. And as can be seen in Figure 1 the paper machine is quite large and preparations were being made for roll and felt changes during the following shutdown. The monitoring equipment and cabling had to be placed in such a way as not to interfere with normal day to day operations, or the shutdown.

The monitoring equipment was placed at two separate locations. The first location was near the wet end of the dryer just beyond the blue roll on the floor in Figure 1. That equipment monitored the former and press sections, as well as a few channels from the back side of the dryer. The instrumentation consisted of: a 56 channel data acquisition and vibration analysis system; and a 16 channel digital tape recorder.

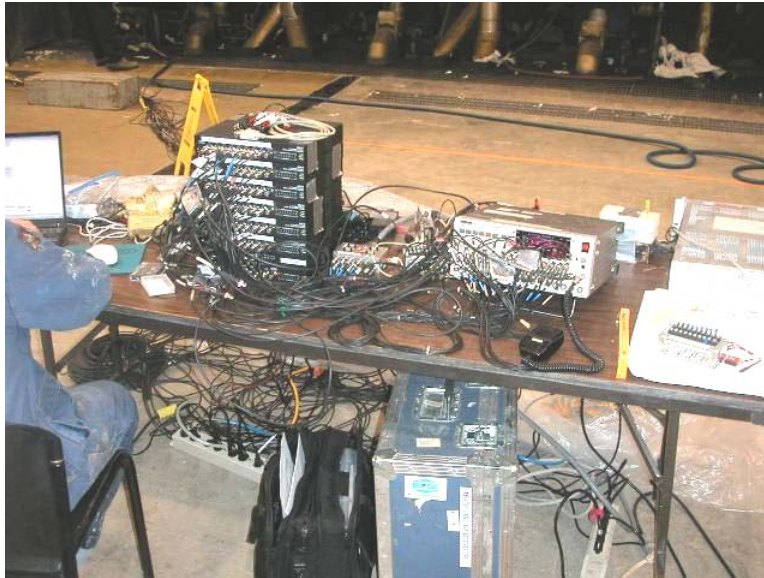
Figure 2. Former and press data acquisition equipment monitoring 56 vibration and 4 tachometer channels.

The resulting cabling setups at the monitoring end are shown in Figures 2 and 3. Bookkeeping became its own challenge during the setup. It was vitally important to be certain that any given accelerometer was mounted in the correct location, the correct direction, and was then connected to the correct channel on the appropriate instrument.

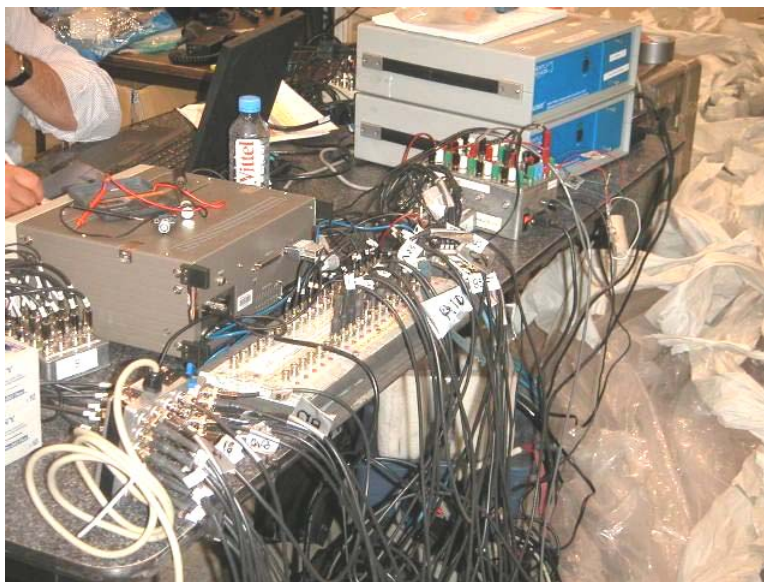
Figure 3. Dryer and calender stack monitoring equipment 32 vibration and 2 tachometer channels.

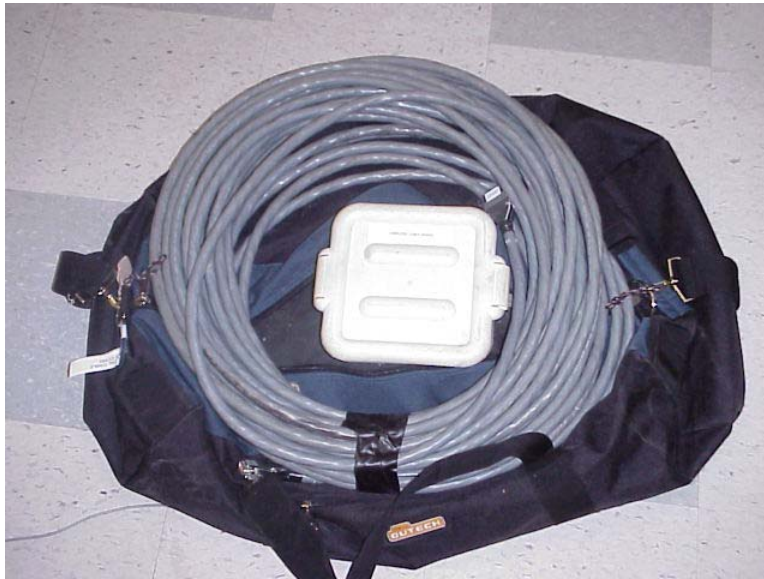
Figure 4. The 12 channel umbilical cable – 30 metres in length with serial connector ends.

cables were used: one with 12 channels and two with 16 channels. The 12 channel umbilical is shown in Figures 4 and 5.

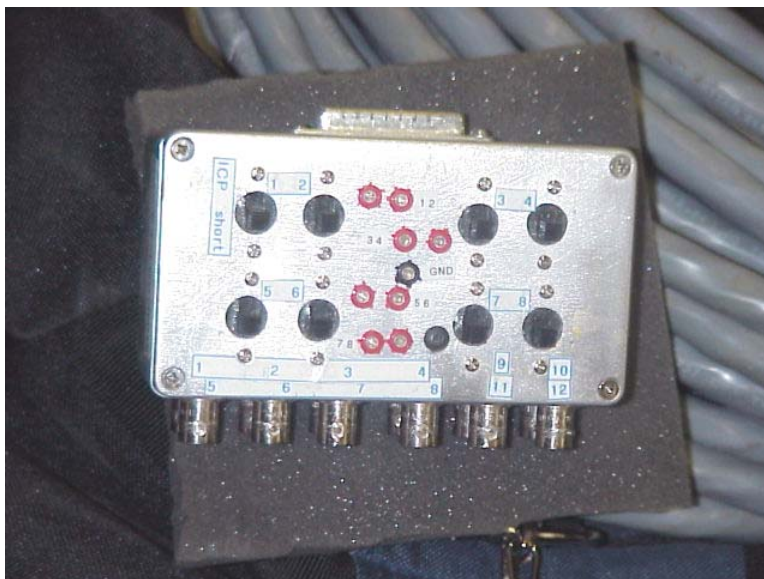
Figure 5. One of the umbilical end boxes with BNC connectors for 12 channels.

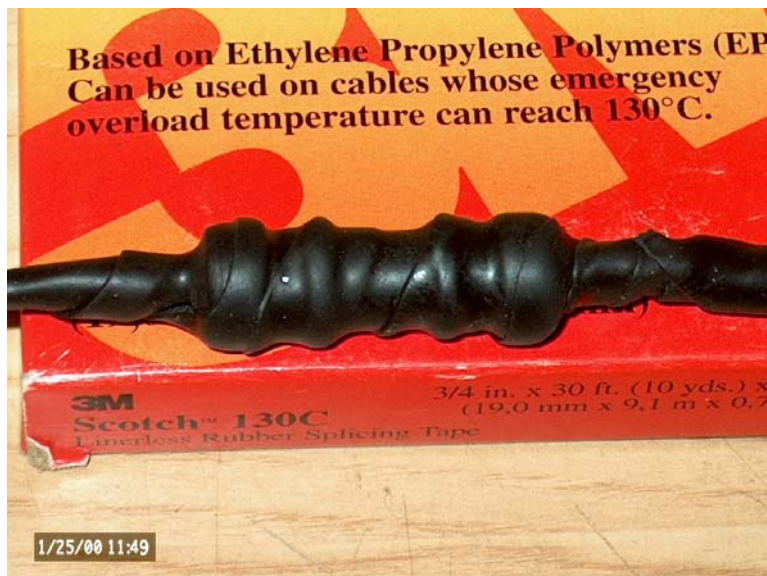
Figure 6. A BNC to BNC connection covered with electrical splicing tape to make water resistant.

Moisture was an additional problem, especially in the former and press sections of the paper machine. Although the number of connectors were minimized, it was necessary to connect two BNC cables with a union. These connections, along with the mil-spec connections at the accelerometer ends were not water resistant. To overcome this, all connections in the wet end of the paper machine were covered with electrical splicing tape as shown in Figure 6. The tape bonds to itself where it overlaps and forms a reasonably water tight seal. This is an extra time consuming step, but the reduced time and aggravation due to wet connections was well worth it. However, the tape is difficult to remove when tearing down the equipment.

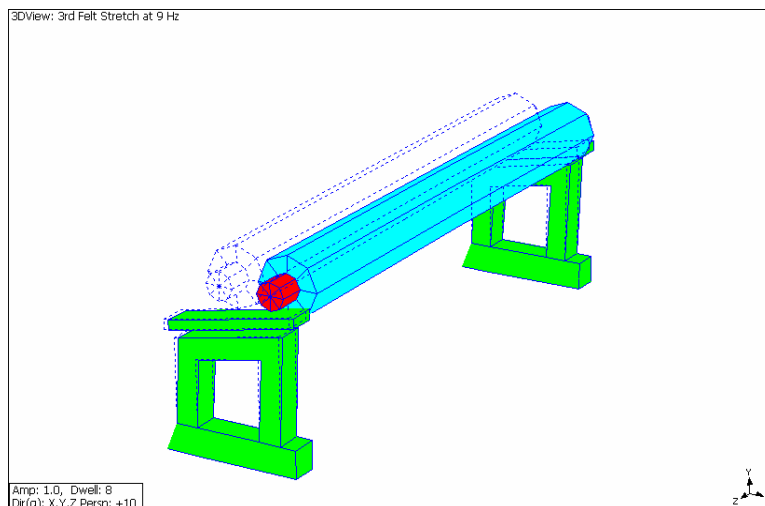
Figure 7. Mode shape of the 9 Hz natural frequency of the 3<sup>rd</sup> press stretch roll.

During the subsequent shutdown, mechanical natural frequency testing on the press section was conducted, with the 3<sup>rd</sup> press stretch roll and its frame receiving considerable effort. The impact testing shows that stretch roll had natural frequencies at 9, 13 and 47 Hz in the horizontal direction. The first natural frequency at 9 Hz has a mode shape shown in Figure 7 below. The front and back sides of the roll were moving in phase in the longitudinal machine direction. The mode shape of the 13 Hz natural frequency was one where the front and back sides of the roll were moving out of phase in the longitudinal machine direction (see Figure 8). Both of these natural frequencies are rigid body modes of the roll. That is, the roll does not bend, but moves as a rigid body relative to the stretch track. The flexibility appeared to be in the track mechanism itself as the track and support frame motion were at significantly lower amplitudes than the roll itself.

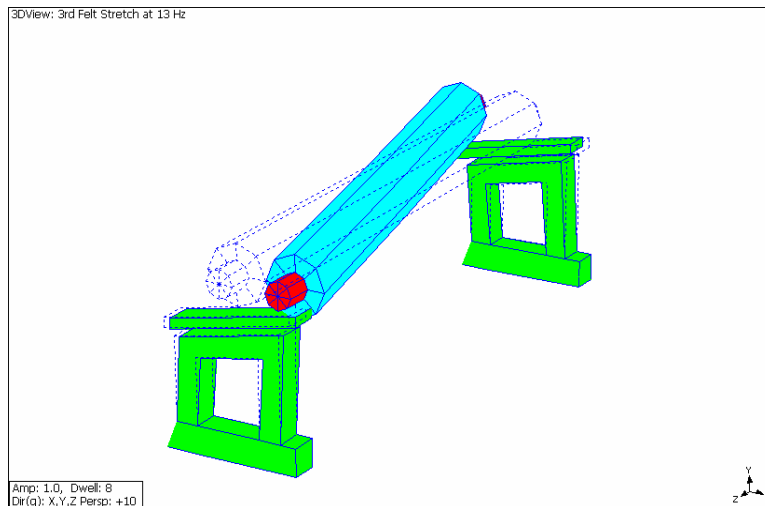
Figure 8. Mode shape of the 13 Hz natural frequency of the 3<sup>rd</sup> press stretch roll.

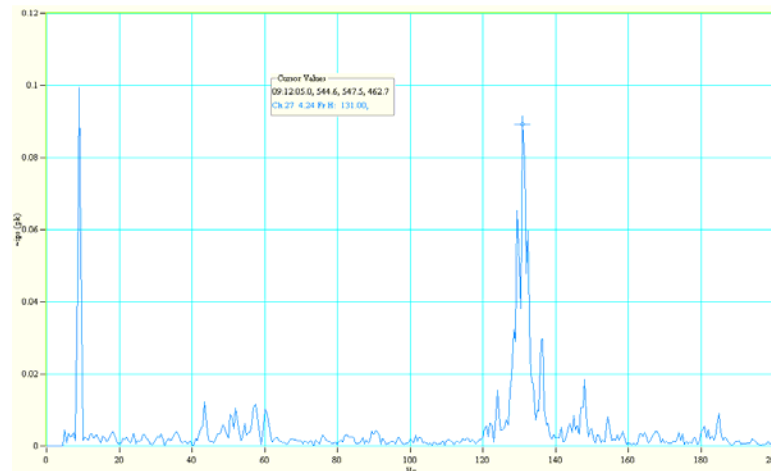
Figure 9. Profile roll vibration spectra showing 1x vibration and 130 – 132 Hz vibration.

Barring of the 4<sup>th</sup> press profile roll had also been a concern. The frequency of the barring had been at 132 Hz. During the speed trial, a vibration component near the barring frequency grew in amplitude, suggesting a possible resonance. A sample spectrum measured on the profile roll bearing housing is shown in Figure 9. This barring frequency vibration disappeared when the sheet was broken and the presses were unloaded.

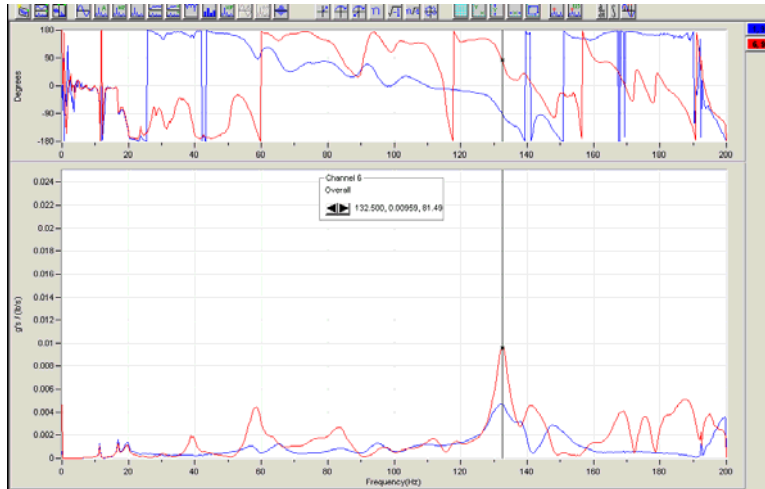
Figure 10. Mechanical natural frequency of profile roll doctor back assembly in the horizontal direction at 132.5 Hz. Chan 1 (blue) is response at the mid-span, and Chan 6 (red) is response at the  $\frac{1}{4}$  point of the doctor back assembly from the front side.

A portion of the mechanical natural frequency testing of the press section concentrated on finding components with natural frequencies in the barring frequency range during the shutdown. Two were found: the double doctor assembly of the profile roll (see Figure 10 for impact test data); and a cross-machine structural member just below the profile roll (see Figure 11 for impact test data).

The finding of two resonant machine items at 132 Hz makes the onset of barring possible from normally inconsequential events. They include:

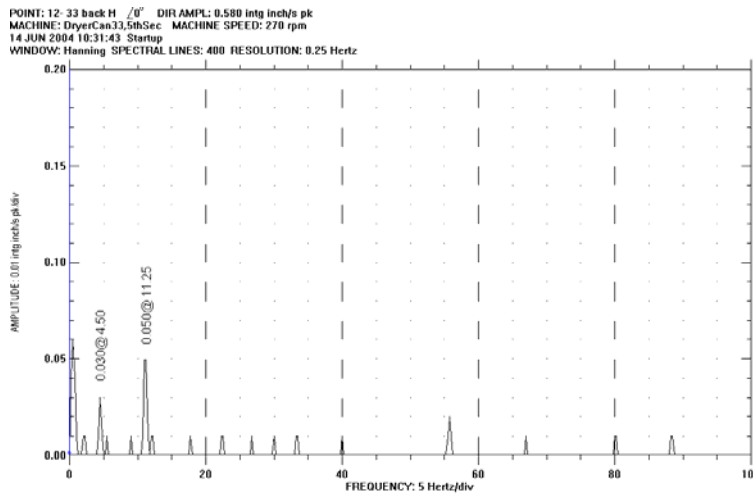
Figure 12. Spectrum of the horizontal vibration of dryer can 33. Note that vibration at suction blow roll rotational (11.25 Hz) was higher than that at dryer can rotational (4.50 Hz).

Historically there have also been concerns with widespread vibration at suction blow roll rotational frequencies in the dryer section. Surprisingly this vibration has often been dominant even on the much larger and much heavier dryer cans. A sample spectrum of horizontal vibration of one of the dryers taken during the speed trial is shown in Figure 12.

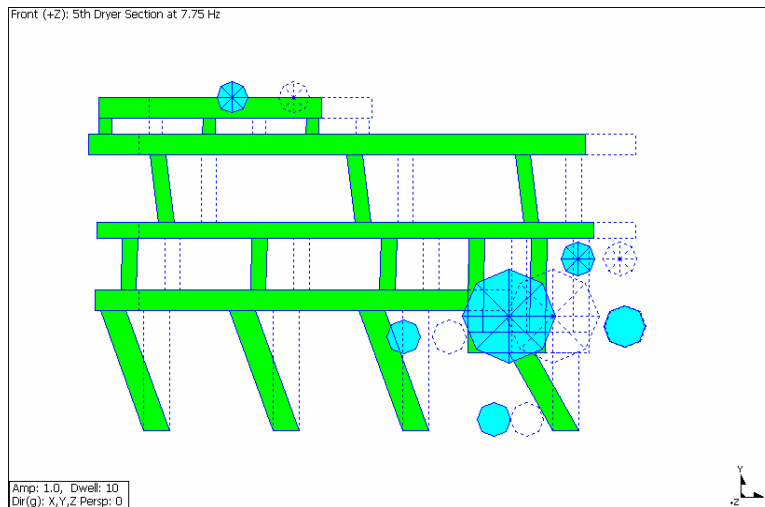
Figure 13. Mode shape of the dryer frame at 7.75 Hz.

This widespread response suggested a resonance in the dryer frame. The manufacturer had originally predicted horizontal frame modes of 7.1 Hz and 13.5 Hz. The mechanical natural frequency tests found modes at 7.75 and 11.2 Hz. The mode shapes are shown in Figures 13 and 14 below. Note that only the rolls that had measured responses during the impact tests are shown in the mode shapes. The measured horizontal mode shapes of the dryer frame are similar to those calculated by the vendor. The first mode had a much stronger response to input than the second mode. However, there is obviously sufficient excitation energy imparted by the suction blow rolls at their rotational frequency to cause widespread vibration of the dryer frame.

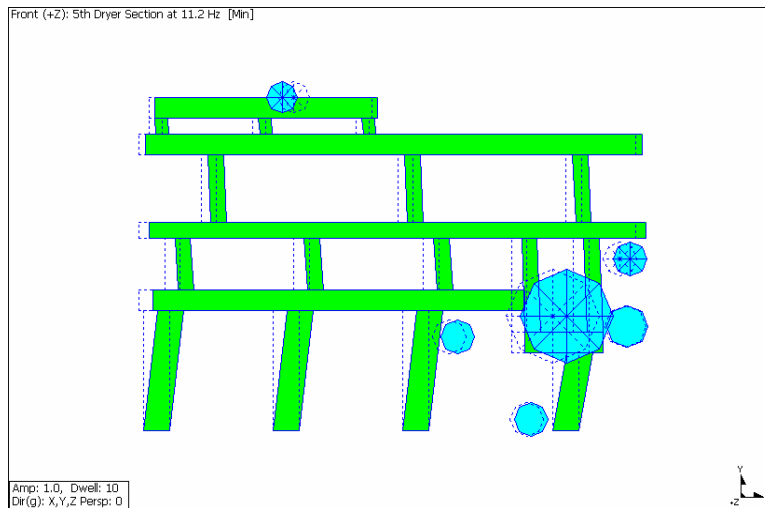
Figure 14. Mode shape of the dryer frame at 11.2 Hz.
