**“COMPRESSOR HASN’T RUN THIS QUIETLY OR SMOOTHLY  
IN 18 YEARS OF OPERATION”  
A CASE STUDY ABOUT FIELD DE-TUNING OF MECHANICAL  
RESONANCE ON FIXED SPEED SCREW COMPRESSOR PACKAGES**

**ABSTRACT**

A field vibration analysis was conducted on a refrigeration screw compressor unit. The purpose of the analysis was to field de-tune high vibration on the compressor package.

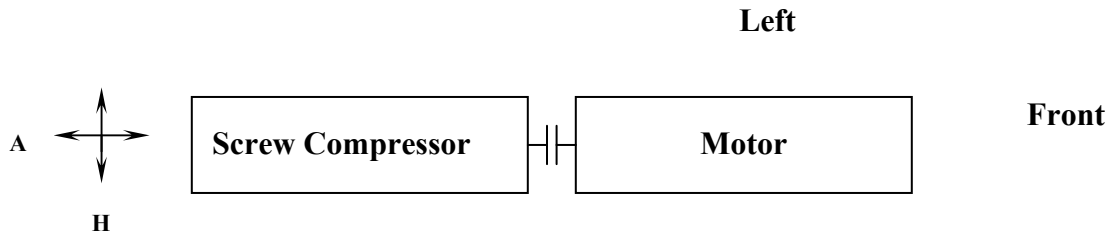
**Unit Layout Top View**

<b>Job: Dow C118</b>			<b>Date: 06/13/02</b>			
<b>Test Pt.</b>	<b>CH</b>	<b>Description</b>	<b>HVA</b>	<b>ips peak @ 118.75 Hz unless noted</b>	<b>Test #</b>	<b>Note</b>
V02	A	Vessel D118 ¼ up from base, location B	HA	1.65	1	
V17	A	Vessel D118 ¼ up from base, location B	HA	1.36	4	
V28	A	Discharge line under coupling	H	1.4	6	
V28	B	Discharge line under coupling	V	3.4	6	
V31	A	Discharge line, lower elbow before D118	H	1.3	6	
V31	B	Discharge line, lower elbow before D118	V	2.8	6	
V37	A	Discharge line, lower elbow before D118	H	0.15	12	
V37	B	Discharge line, lower elbow before D118	V	0.58	12	
V38	A	Discharge pipe near drain line	V	0.54	12	
V38	B	Discharge drain line flange	V	0.60	12	
V40	A	Vessel D118 ¼ up from base, location B	HA	0.19	13

- 1 Vibration on discharge separator D118 with the bottom band clamp tight around vessel.
- 4 Vibration with four vessel bands on and four 4" 150# flanges hanging from the D118 discharge line. Vibration @ 118 Hz was 4.0 ips in the horizontal @ this location down to 0.6 ips peak on the bottom two 90-degree elbows. Vibration at 118 Hz in the horizontal was greater than 9 ips peak on the drain line under these elbows before the weights, now down to 2.0 ips peak.
- 6 Vibration on the compressor discharge line with the clamp under the coupling end of the motor tight but not shimmed.
- 12 Vibration on the discharge line with two 8" 150 # flanges added as a de-tuning mass to the lower elbow of the discharge line before the cooler.
- 13 Vibration on discharge separator D118 with the as-left de-tuning weights in place.
