RESTORING CRANKSHAFT ALIGNMENT: A CASE HISTORY

Mark L. Deutscher, P.Eng.
Canadian Design Services Representative

Beta Machinery Analysis Ltd., Calgary, AB, Canada, T3C 0J7

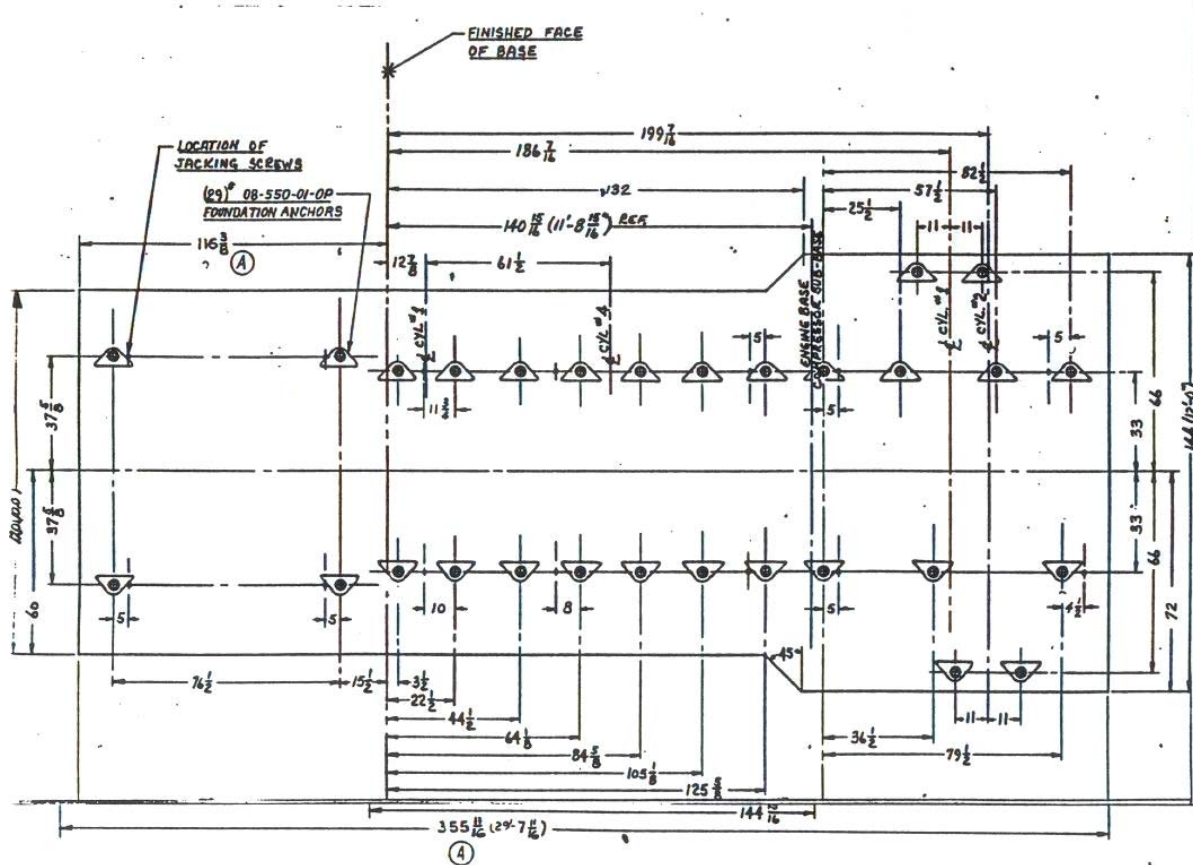
Figure 3: Photocopy of slab detail

The equipment rests on a concrete slab 30' long by 10' wide at the engine end, 12' wide at the compressor end (extending out to catch the crosshead guide supports). The slab is nominally 2' thick. It is stated that the slab is to be "suitably reinforced" with steel but no details for such were found. A total of 29 1 1/4" dia. fine thread anchor bolts with hardened steel washers secure the equipment base to the foundation slab. See Figure 3 for a detailed view.

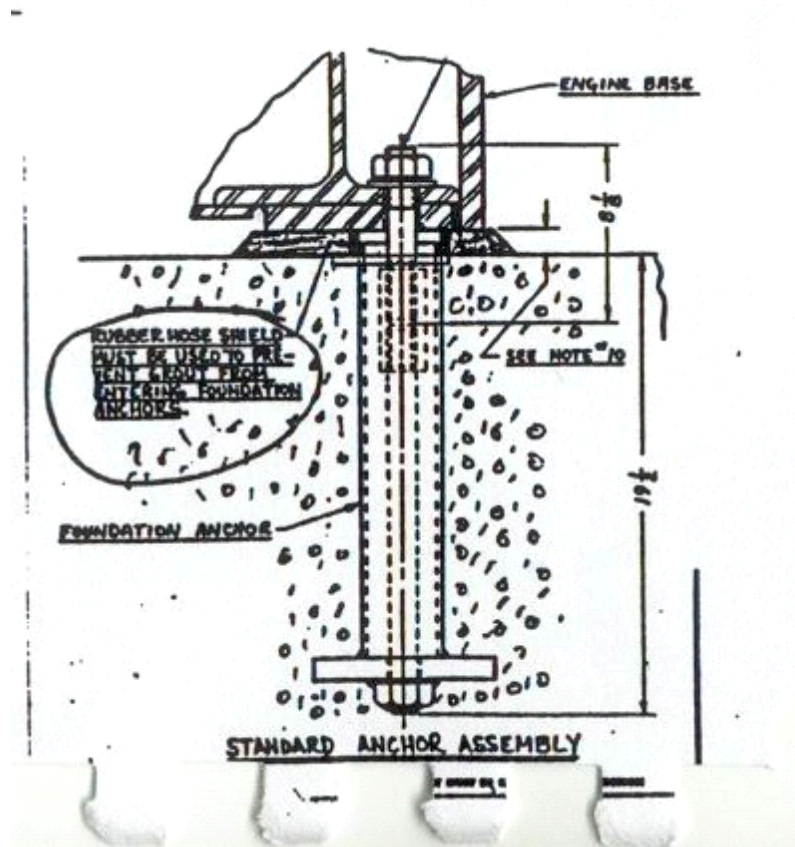
Figure 4: Photocopy of specified anchor detail

In the available drawings for this installation a standard anchor detail shows an anchor in tube assembly with 19 1/2" embedment. The grout connection is a full length 1" thick steel rail embedded in a raised sanded Portland cement grout bed. It is noted that the grout bed is to be between 1" and 2" thick. The foundation surface is to be thoroughly chipped to expose clean, dry, sharp aggregate prior to grouting. The illustration in Figure 4 shows a blowup of excellent anchor detail.
